# MARY ERSKINE BUILDING MEP ASSESSMENT REPORT

## DEBRA J. DOCKERY, ARCHITECT, P.C.

**Report**

CLCE Project # 25-022

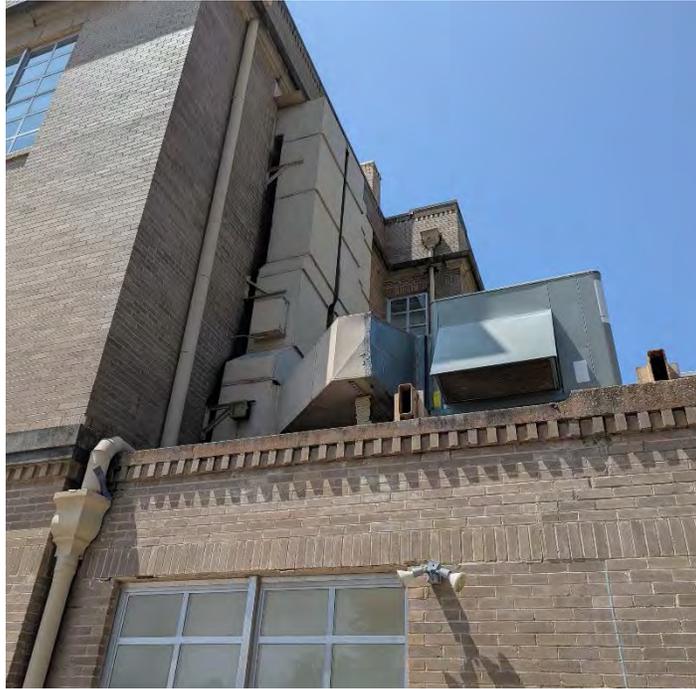
A total of four packaged Rooftop Units (RTUs) were installed on the roof of portions of the first floor, with two on the northeast corner and two on the northwest corner. Each RTU has gas piping routed to it for reheat. Supply and return duct come out horizontally from the unit, and run up along the side of the building into penetrations on the second and third floor. The duct does not appear to be insulated or protected from the elements. While not being able to be observed directly, it was noticed from observations that pieces were missing from the RTUs. The exterior cabinets looked weathered as well.

*Figure 1. Packaged RTUs as seen from ground level*

Outdoor packaged rooftop units would be replaced with new units with variable capacity compressors. The units would have higher efficiency and variable flow fans. New variable air volume terminal units with electric reheat would be installed to accommodate new zoning and occupancies.

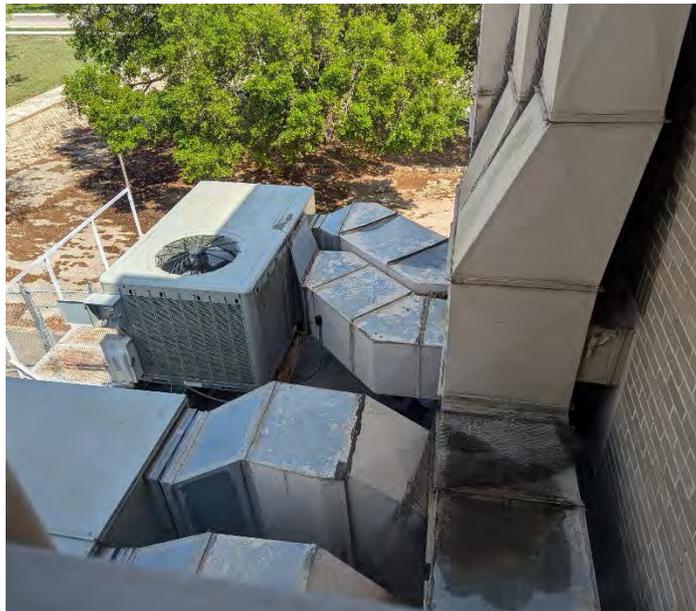
*Figure 2. Packaged RTUs as seen from indoor space*

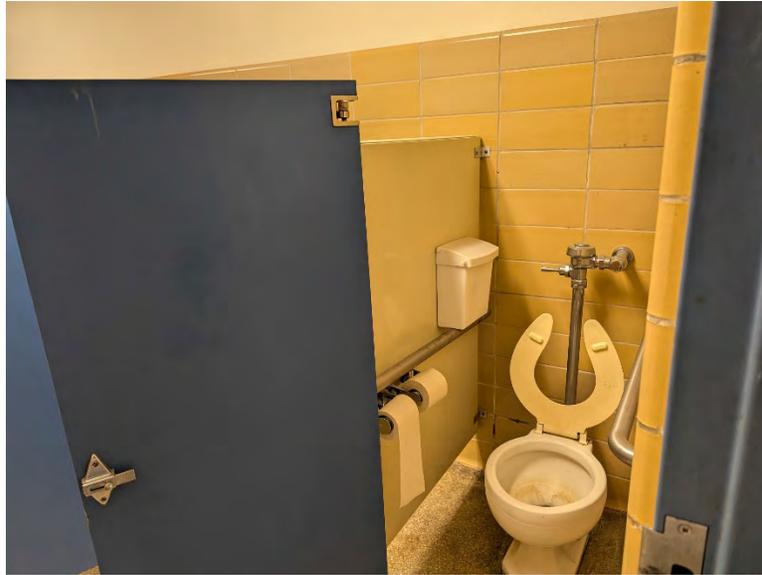
The water closets and urinals were in poor to fair condition. However, many were not sized for adults. The fixtures also were not ADA compliant.

*Figure 3. Typical water closet*

It is recommended that the plumbing sanitary and domestic water lines be scoped by a plumber to check for pipe integrity for potential reuse. Any new piping will be copper for the domestic water and PVC for sanitary and vent. All existing fixtures are recommended to be removed and replaced with new fixtures, along with ADA-compliant options. Each floor is recommended to have its own new 10 gallon electric water heater.

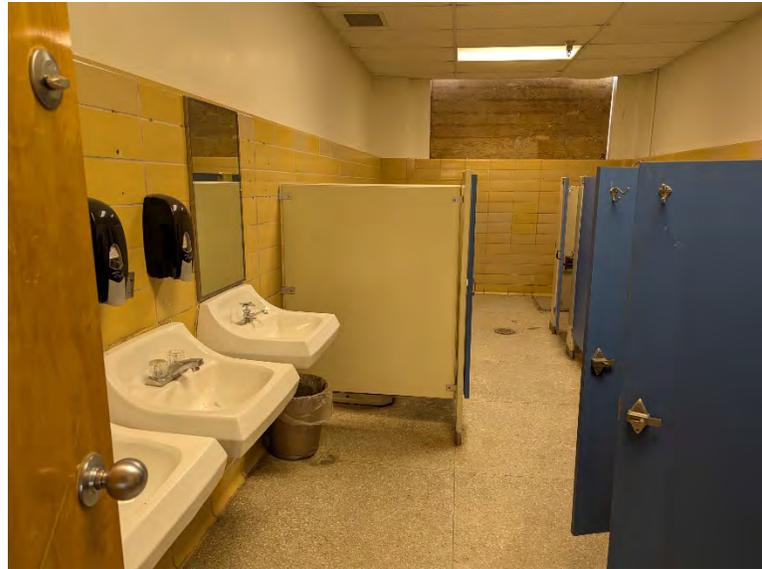
The piping behind the walls or underneath the floor were not able to be observed . It is not known the condition of the domestic water pipe or the sanitary sewer pipe in those locations. The piping that was exposed to feed the fixtures looked to be in good condition. Some lavatories had only cold water service and some had cold and hot water. The lavatory and faucets looked outdated and not ADA compliant.

*Figure 4. Typical restroom layout*

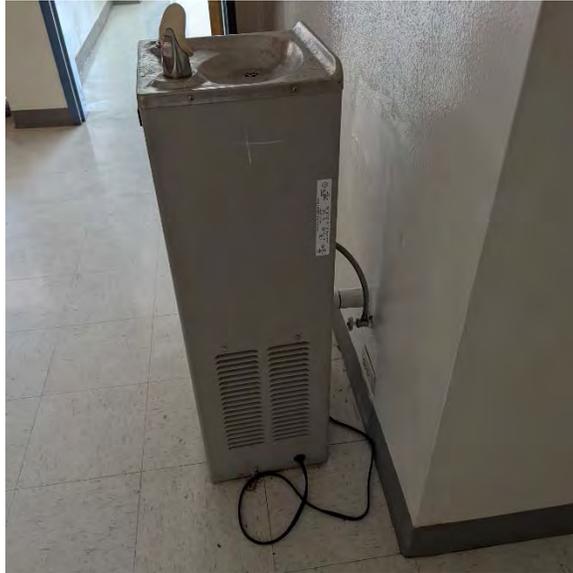
Drinking fountains were observed on each floor. These were in poor condition and were not ADA compliant. No split level fountains or bottle fillers were found.

*Figure 5. Typical drinking fountain*

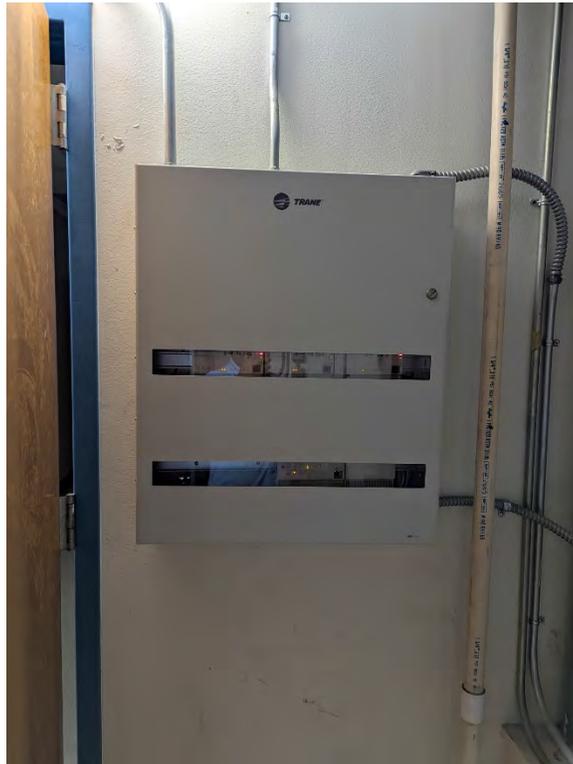
*Figure 6. First floor controls cabinet*

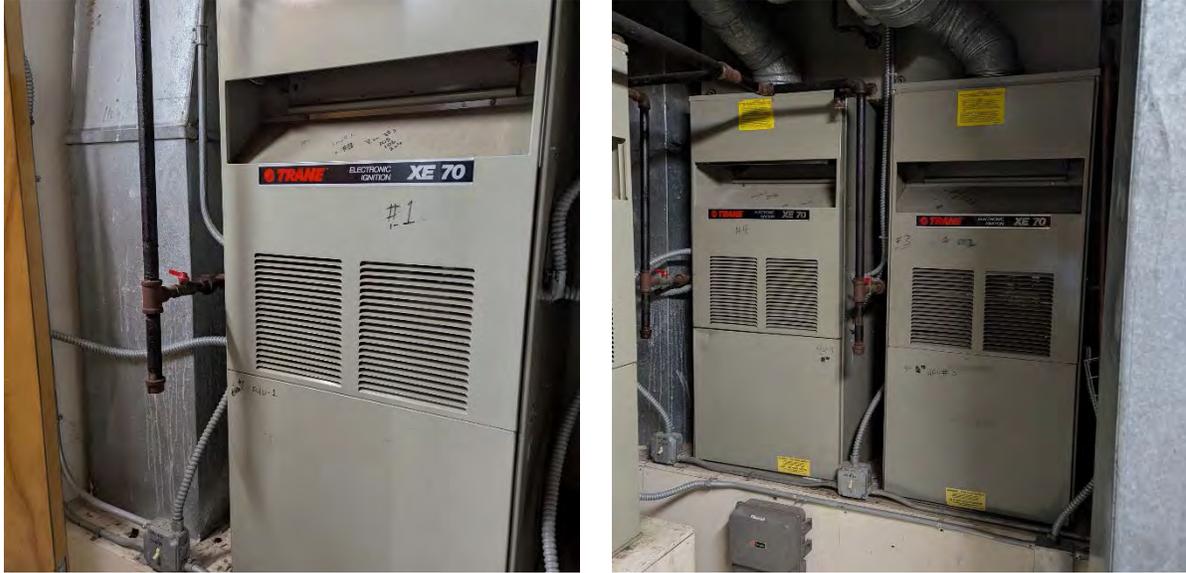
The five indoor air handling units serving the first floor spaces are all located in a mechanical room and mounted on a wooden platform that also serves as a plenum for return air and outside air to mix before the inlet of the air handling units. An outside air duct is routed from outdoor louvers and discharges into the return air mixing box. Supply air ducts rise vertically out of the top connection of the air handlers up to above ceiling and become unobservable for a short distance. Insulation could not be verified on this section of ductwork.

Figure 7. First floor vertical air handlers

This option would involve removing the existing mechanical equipment and replacing with new, similarly functioning equipment. The existing split systems would be replaced with new variable capacity heat pumps. The indoor vertical air handlers would be replaced with higher efficiency fan models.

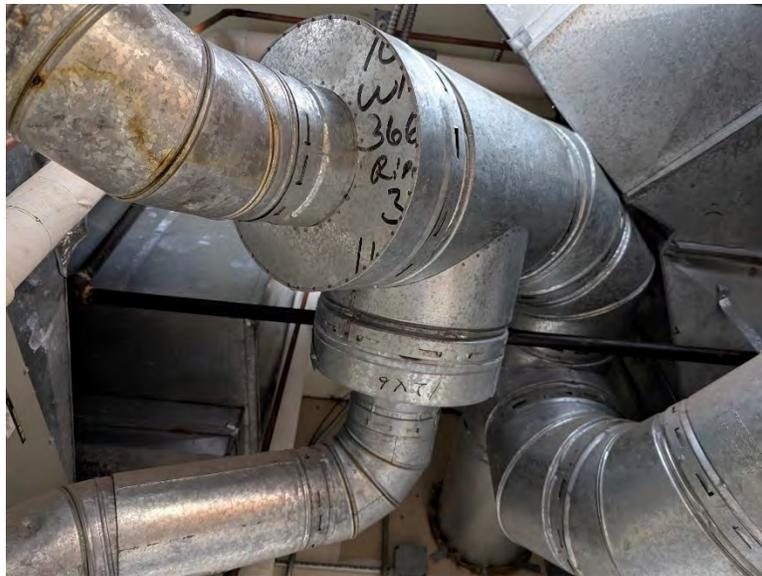
Figure 8. Various ducts tied to vertical air handlers

Ductwork would be inspected and replaced as needed, and air devices would be replaced. A centralized control system using wireless controllers would be installed to control all mechanical equipment.

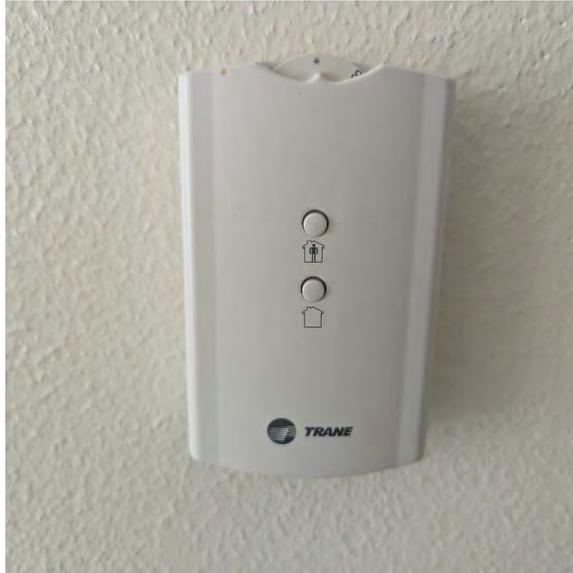
*Figure 9. Second floor standalone control thermostat*

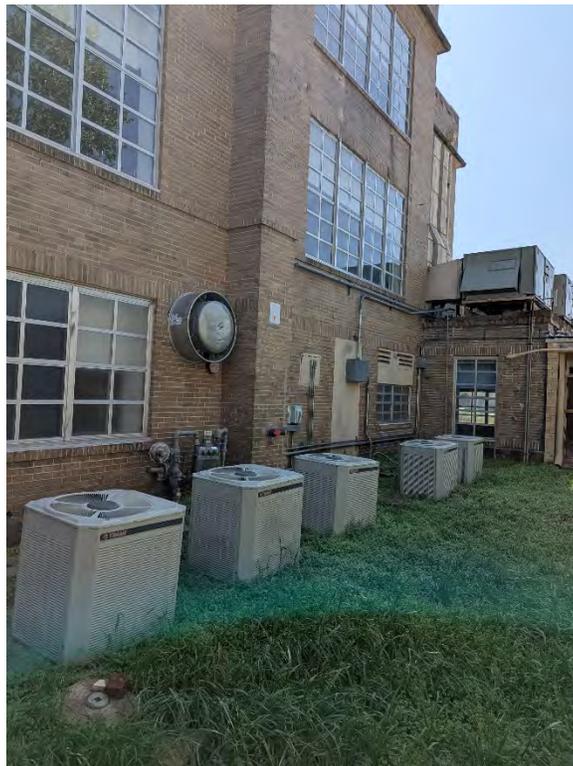
The outdoor air conditioners are mounted to concrete pads just outside of the building in between the main building and gym. The units were observed to be in poor condition and had components missing. The nameplates showed all were the same 5-ton model and manufactured in 1991.

*Figure 10. First floor outdoor units in mechanical yard*

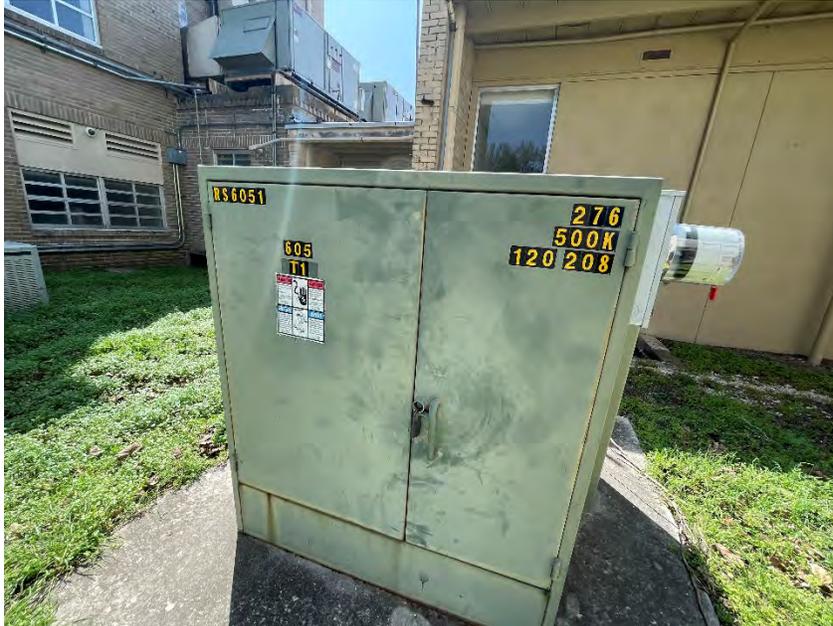
Electrically, the building is served by a 208Y/120V 500kVA utility transformer, which is likely to be sufficient for the renovation. The electrical distribution equipment appears to be dated from 1990 to 2000. The main switchboard was unable to be opened during the site visit. Based on the age of the equipment, it is recommended to replace the electrical distribution equipment and feeders. The new layout of the building and HVAC renovations will also likely require a reconfiguration of the distribution system. Additionally, this will allow for a more efficient electrical design that requires fewer pieces of equipment that can be consolidated to one area, instead of placed throughout the facility.

Figure 16. Utility transformer

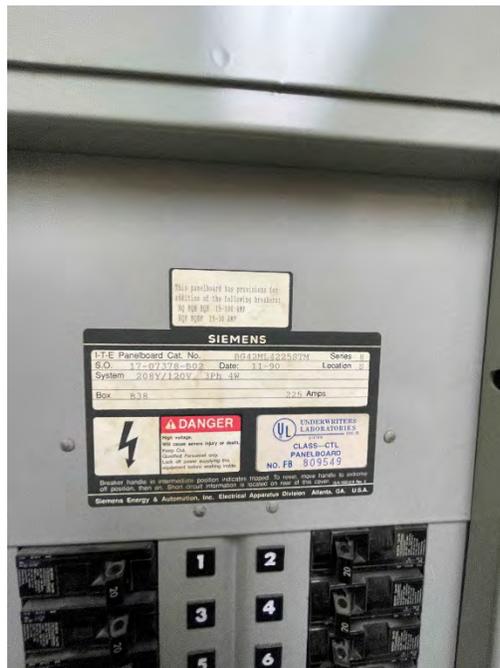
Figure 17. Panelboard nameplate showing a date of 1990

Based on observations of the site, it is recommended that the electrical distribution equipment and feeders be replaced. It is also recommended the at the lighting fixtures and controls be replaced. Additionally, the fire alarm system appears to be dated. Some work will be required to cover the new building layout. It is recommended to replace the fire alarm system to ensure full functionality. Electrical devices appear dated. They can remain, but device/wall plate replacement and raceway relocation is recommended to improve the aesthetics of the new spaces.

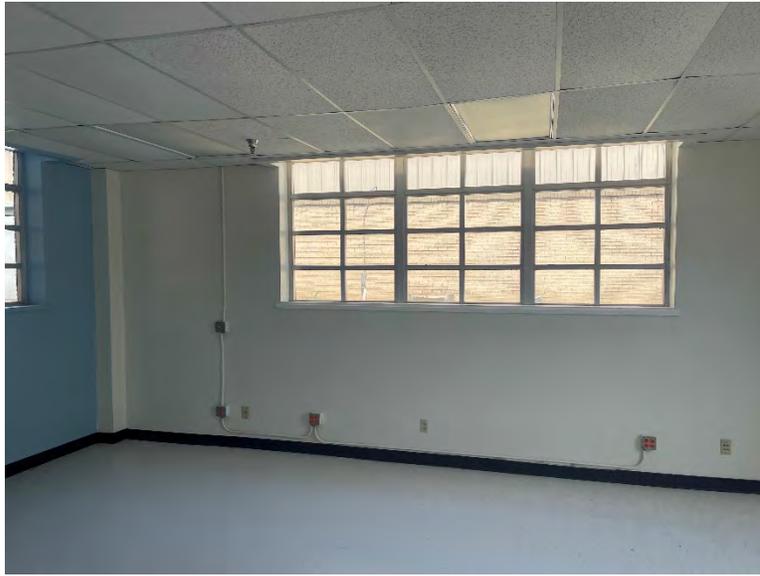
The devices appear dated. Some devices appear to have been added at a later date, and have surface mounted raceway providing power to the receptacles. There is an isolated grounding system in place for some of the receptacles. This can be left intact, but is not required. Optionally, the devices and face plates can be replaced and the raceways moved to inside the walls to freshen up the space.

Figure 83. Typical wall showing orange isolated ground receptacles and surface mounted raceway

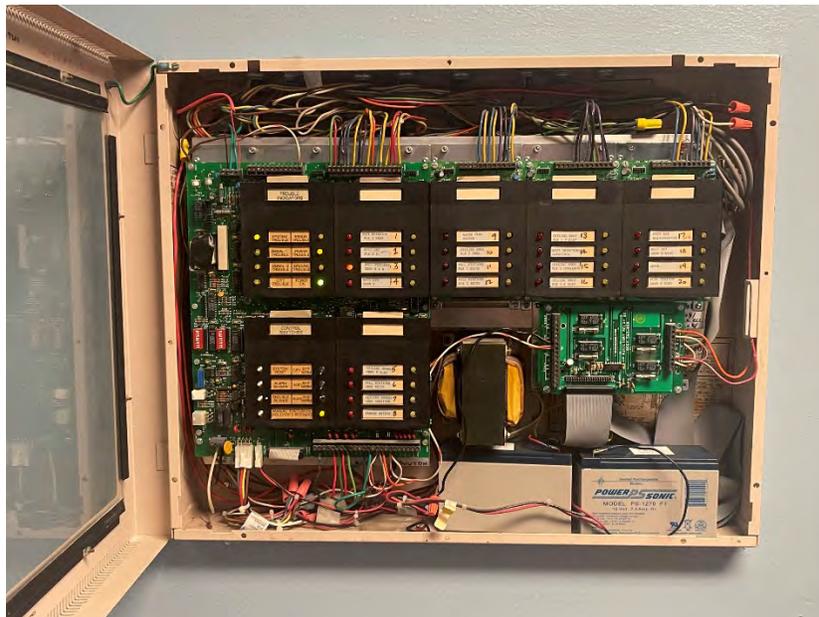
Figure 14. Existing fire alarm control panel
